# ALDER POINT OFFICE CENTER

BUILDING CONDITION WALKTHROUGH

Sep 23, 2026 - 9:00 AM-9:28 AM

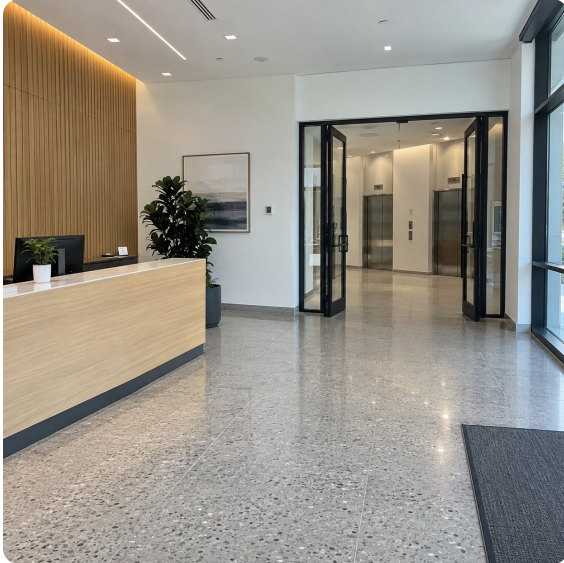
Level 1 - reception / elevator lobby

## Observation 1: Reception and elevator approach clear

The route from the reception desk to the elevator lobby was clear at the time of the walk. Furniture remained within the seating and reception areas, and no delivery cartons, loose cables, or cleaning equipment were visible in the main circulation path. The terrazzo floor appeared dry and free of loose debris. The glass doors and adjacent glazing showed no obvious visible damage from the standing inspection position.

**Follow-up:** No corrective work is proposed for this observation. Retain the image as a condition reference and continue routine housekeeping checks.

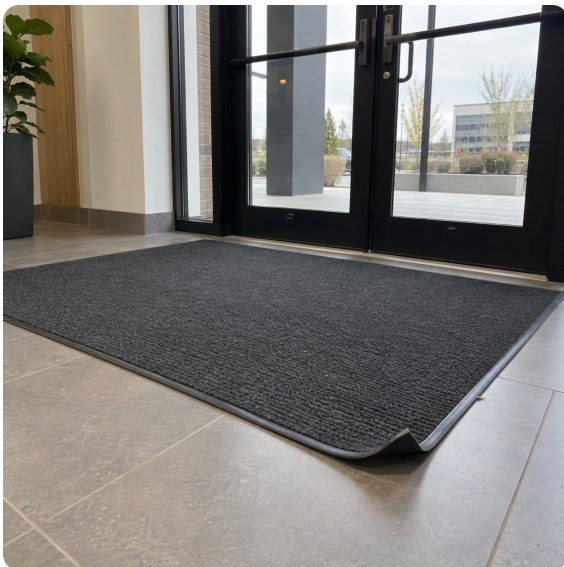
Level 1 - main entrance vestibule

## Observation 2: Replace curled entrance mat

The near-right corner of the charcoal walk-off mat curls upward where visitors enter from the glass doors. The raised edge interrupts an otherwise level route across the vestibule and could catch a shoe or trolley wheel. The surrounding tile appears dry, with no visible spill contributing to the condition. The issue is localized to the mat edge; the image does not establish damage to the underlying floor.

| # | ACTION | ASSIGNED | STATUS | LOCATION |
|---|---|---|---|---|
| 2 | Replace curled entrance mat; verify flat edges | Facilities | Unsent | Entrance<br>Level 1 |

**Follow-up:** Facilities should remove or replace the curled mat, confirm the replacement lies flat, and photograph the corrected entrance before closing the task.

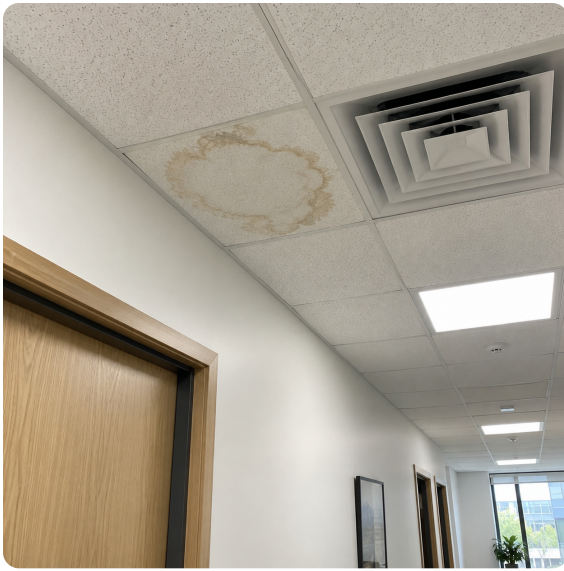
Level 2 - corridor outside Meeting Room 204

### Observation 3: Investigate ceiling-tile water stain

One acoustic ceiling tile beside a ventilation diffuser has an irregular tan ring. Adjacent tiles and the nearby light panel show no similar discoloration in the photographed area. No active dripping is visible, and the surface condition alone cannot establish whether the source is current moisture, a previous event, plumbing, or condensation. The ceiling void was not opened during this visual walkthrough.

| # | ACTION | ASSIGNED | STATUS | LOCATION |
|---|---|---|---|---|
| 3 | Investigate stain source before replacing tile | Maintenance | Unsent | Corridor<br>Level 2 |

**Follow-up:** Building maintenance should investigate the source, document moisture findings, and arrange the relevant trade inspection. Replace the tile after the cause is addressed and the area is confirmed dry.

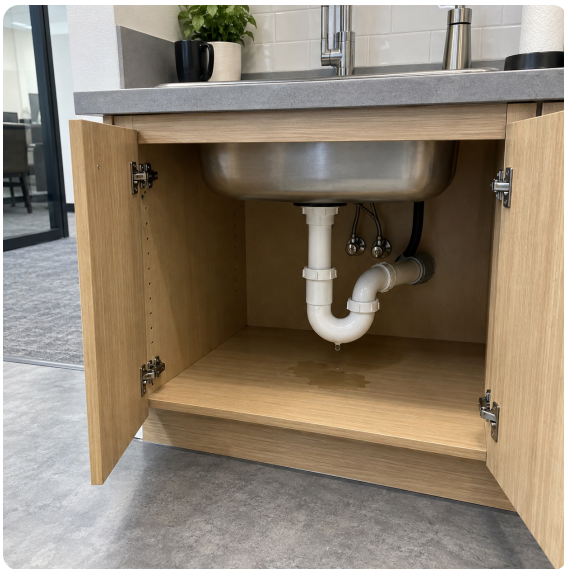
Level 1 - shared kitchenette, sink cabinet

### Observation 4: Check leak beneath kitchenette sink

With the sink cabinet open, a bead of water is visible beneath the white drain trap and a small wet patch has formed on the cabinet base. The visible wet area is confined to the space directly below the waste pipe; no standing water is shown on the room floor. The precise leak point was not confirmed, and the pipework was not dismantled during the walkthrough.

| # | ACTION | ASSIGNED | STATUS | LOCATION |
|---|---|---|---|---|
| 4 | Inspect drain trap; repair, dry and retest | Plumbing | Unsent | Kitchenette<br>Level 1 |

**Follow-up:** Ask the plumbing team to check the trap and connections, correct the leak, dry the cabinet, and run a controlled flow test. Attach an after-photo showing a dry base before closing the task.

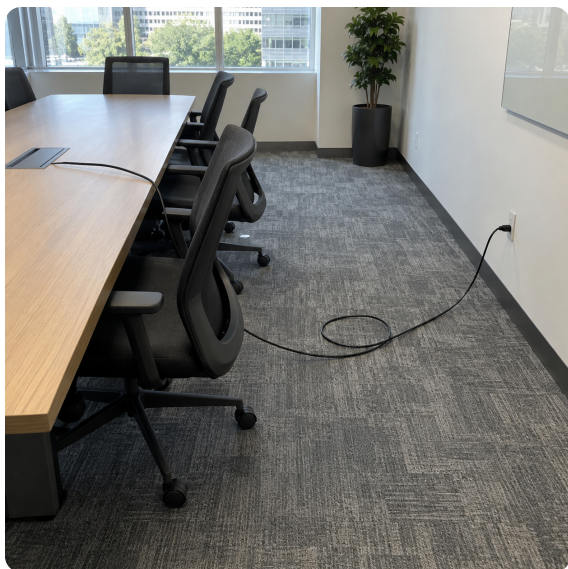
Level 2 - Meeting Room 204, window-side aisle

## Observation 5: Reroute loose conference-room cable

A black cable runs from the meeting-table area toward the wall and forms a loose loop across the aisle behind the chairs. A person walking around the table or moving a chair could catch the cable. The gray carpet tiles appear otherwise flat in the visible area. This observation concerns cable routing; no electrical fault or equipment malfunction was established by the visual check.

| # | ACTION | ASSIGNED | STATUS | LOCATION |
|---|---|---|---|---|
| 5 | Reroute meeting-room cable clear of aisle | IT / Facilities | Unsent | Room 204<br>Level 2 |

**Follow-up:** IT and facilities should reroute the connection through the intended cable-management path, check equipment operation, and verify that chairs can move without pulling the cable back into the aisle.

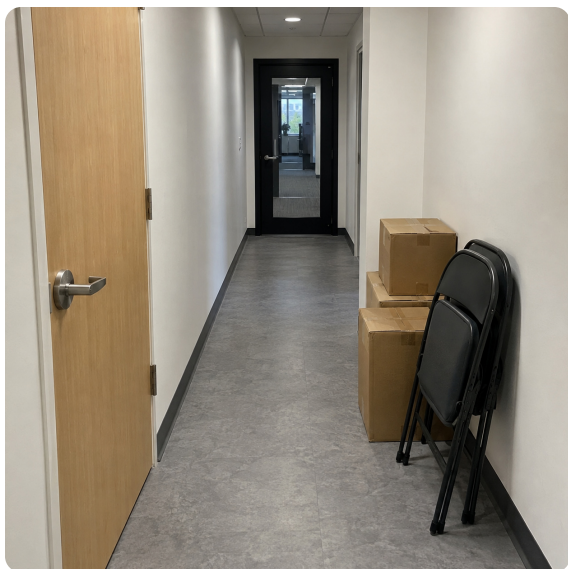
Level 1 - east rear service corridor

## Observation 6: Clear temporary service-corridor storage

Three delivery cartons and two nested folding chairs are stored along the right-hand wall of the rear service corridor. They reduce the available walking space and create a point where staff must steer around stored items. A path remains visible, but the route should be restored to its normal clear width. This is a visual housekeeping finding; no measured clearance or regulatory compliance conclusion is claimed.

| # | ACTION | ASSIGNED | STATUS | LOCATION |
|---|---|---|---|---|
| 6 | Move cartons and chairs to designated storage | Housekeeping | Unsent | Service<br>Level 1 |

**Follow-up:** Move the cartons to receiving storage and return the chairs to their designated store. Recheck the full route and document the cleared corridor in a follow-up photo.
